# Manhole Inspection Summary

Manhole # S35QQ\_016MH

Insp Date: 1/23/07 1:27 PM

**Location** Address: **2500 GUILFORD AVE**

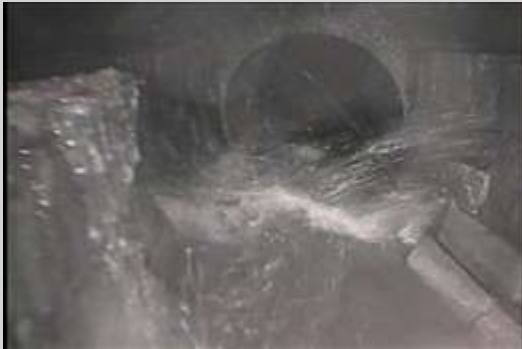
### 15 in. Circular Gravity Sewer Pipe Out @ 12 O'Clock

Pipe Material: **Clay** ☐ Pipe Lined

Invert Depth: **14.00** (ft.) Flow Characteristics: **Fast**

Infiltration: **None** Pipe Seal Cond: **Unknown**

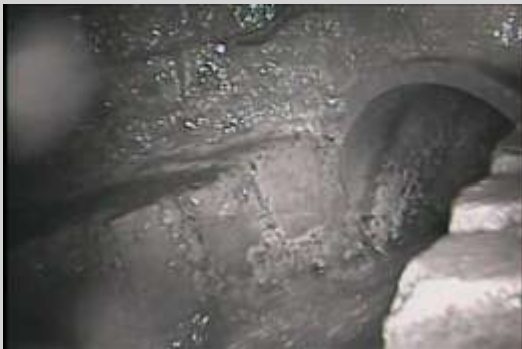
### 8 in. Circular Gravity Sewer Pipe In @ 3 O'Clock

Pipe Material: **Clay** ☐ Pipe Lined

Invert Depth: **13.65** (ft.) Flow Characteristics: **Fast**

Infiltration: **None** Pipe Seal Cond: **Unknown**

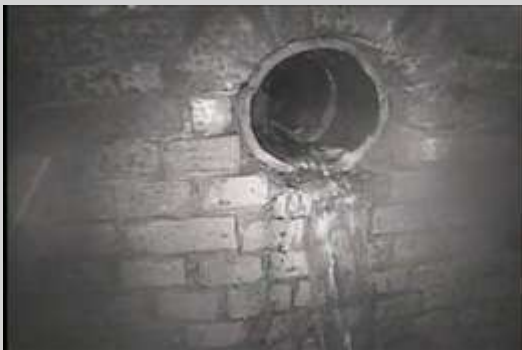
Pipe In @ 9 O'Clock

Pipe Material: **Clay** ☐ Pipe Lined

Infiltration: **None** Pipe Seal Cond: **Unknown**

Drop: **Outside** Rod and Bar  
Angled: **Yes** Reading: **12.55** (ft.)  
Inv Depth: **13.55** (ft.)  
Drop Condition: **Partly Clogged**
